# Manhole Inspection Summary

Manhole # S41II\_017MH

Insp Date: **12/28/07 11:19 AM**

**Location** Address: **401 OLIVER ST**

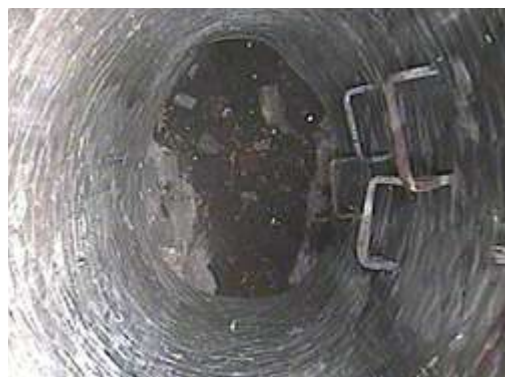
Defect 1

Condition: ☐ Sound ☐ Cracked ☐ Root Intrusion ☐ Deteriorated ☐ Leaks ☒ **Debris**

Count: **7** Missing: **2** ☒ **Corroded**

CORRODED STEPS & DEBRIS

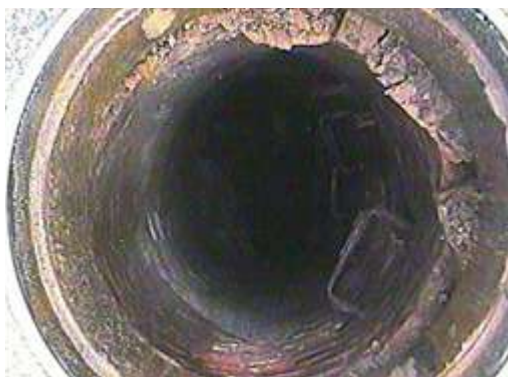
Defect 2

Offset: **3** (in.)

Condition: ☐ Sound ☒ **Cracked** ☐ Root Intrusion ☒ **Loose Brick** ☐ Deteriorated

FRAME OFFSET/CHIMNEY LOOSE  
BRICKS/CHIMNEY CRACKED

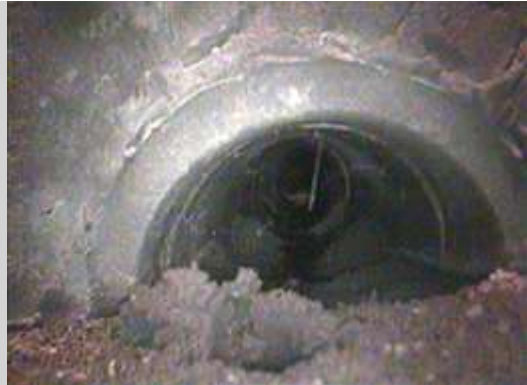
12 O'Clock Outflow

8 in. Circular Gravity Sewer  
Pipe Out @ 12 O'Clock

Deposits: ☐ None ☐ Mud ☐ Sludge ☒ **Debris** ☐ Grease

Silt Depth: **1** (in.) Deposits Extent: **Light**
